CAPITAL RESERVE ANALYSIS
FOR
CEDAR MILL
DALLAS, GEORGIA

PREPARED FOR:

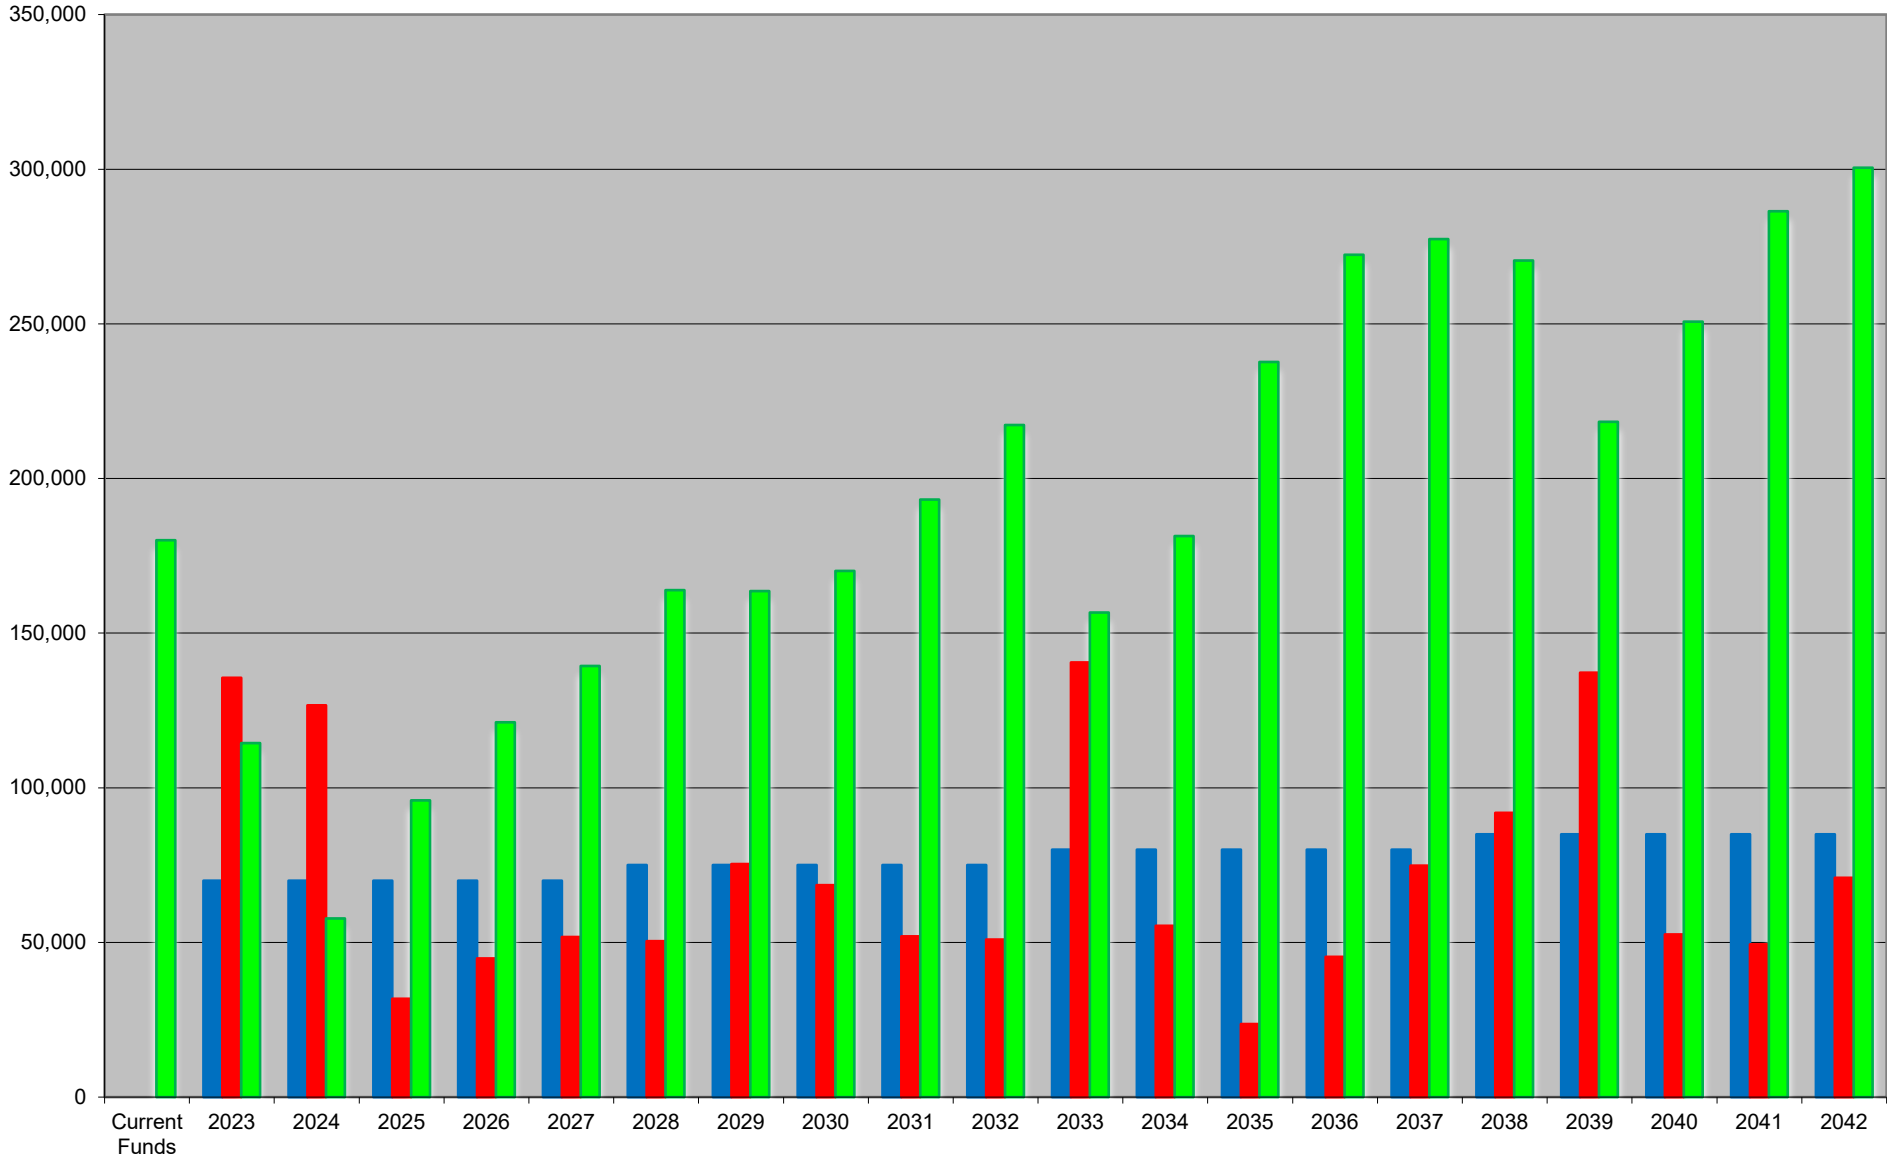
CEDAR MILL - PROJECTED CASH FLOW (CURRENT FUNDING)

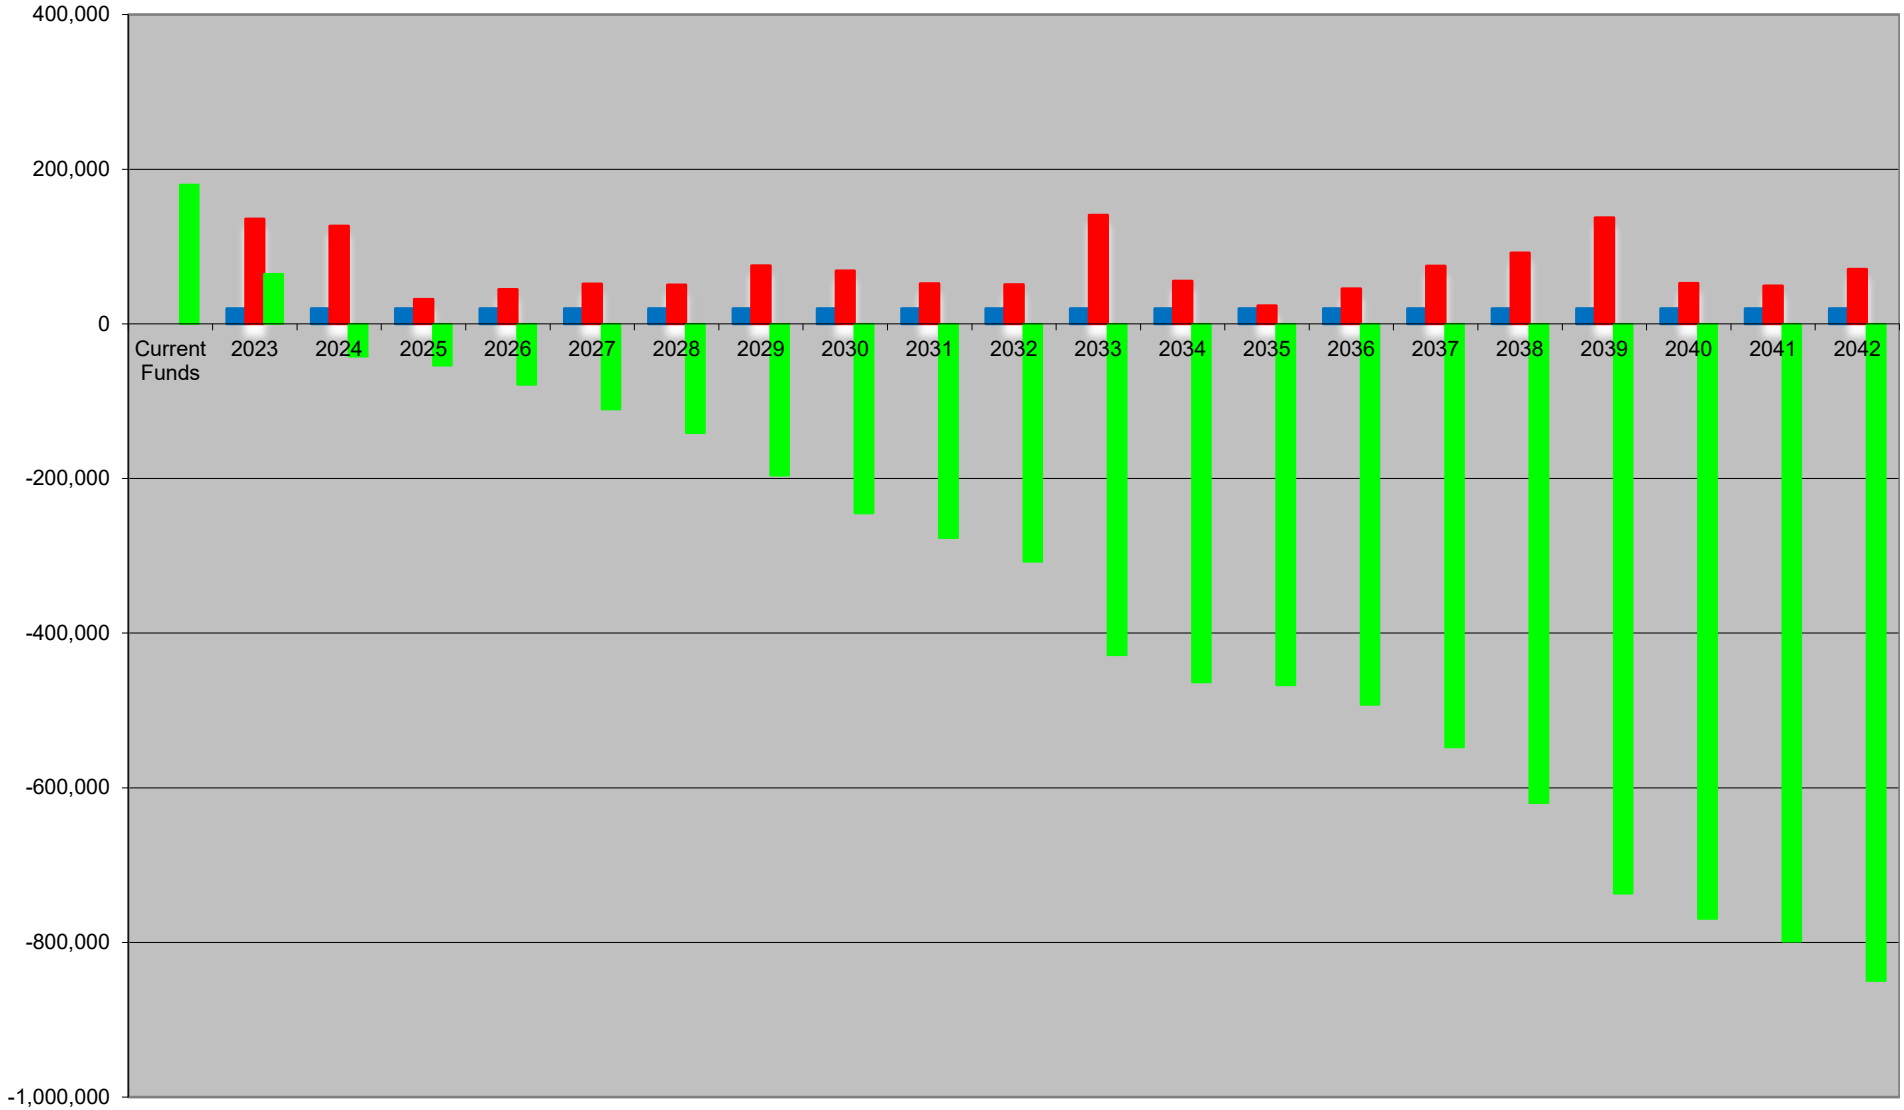
CEDAR MILL - PROJECTED CASH FLOW (RECOMMENDED FUNDING)

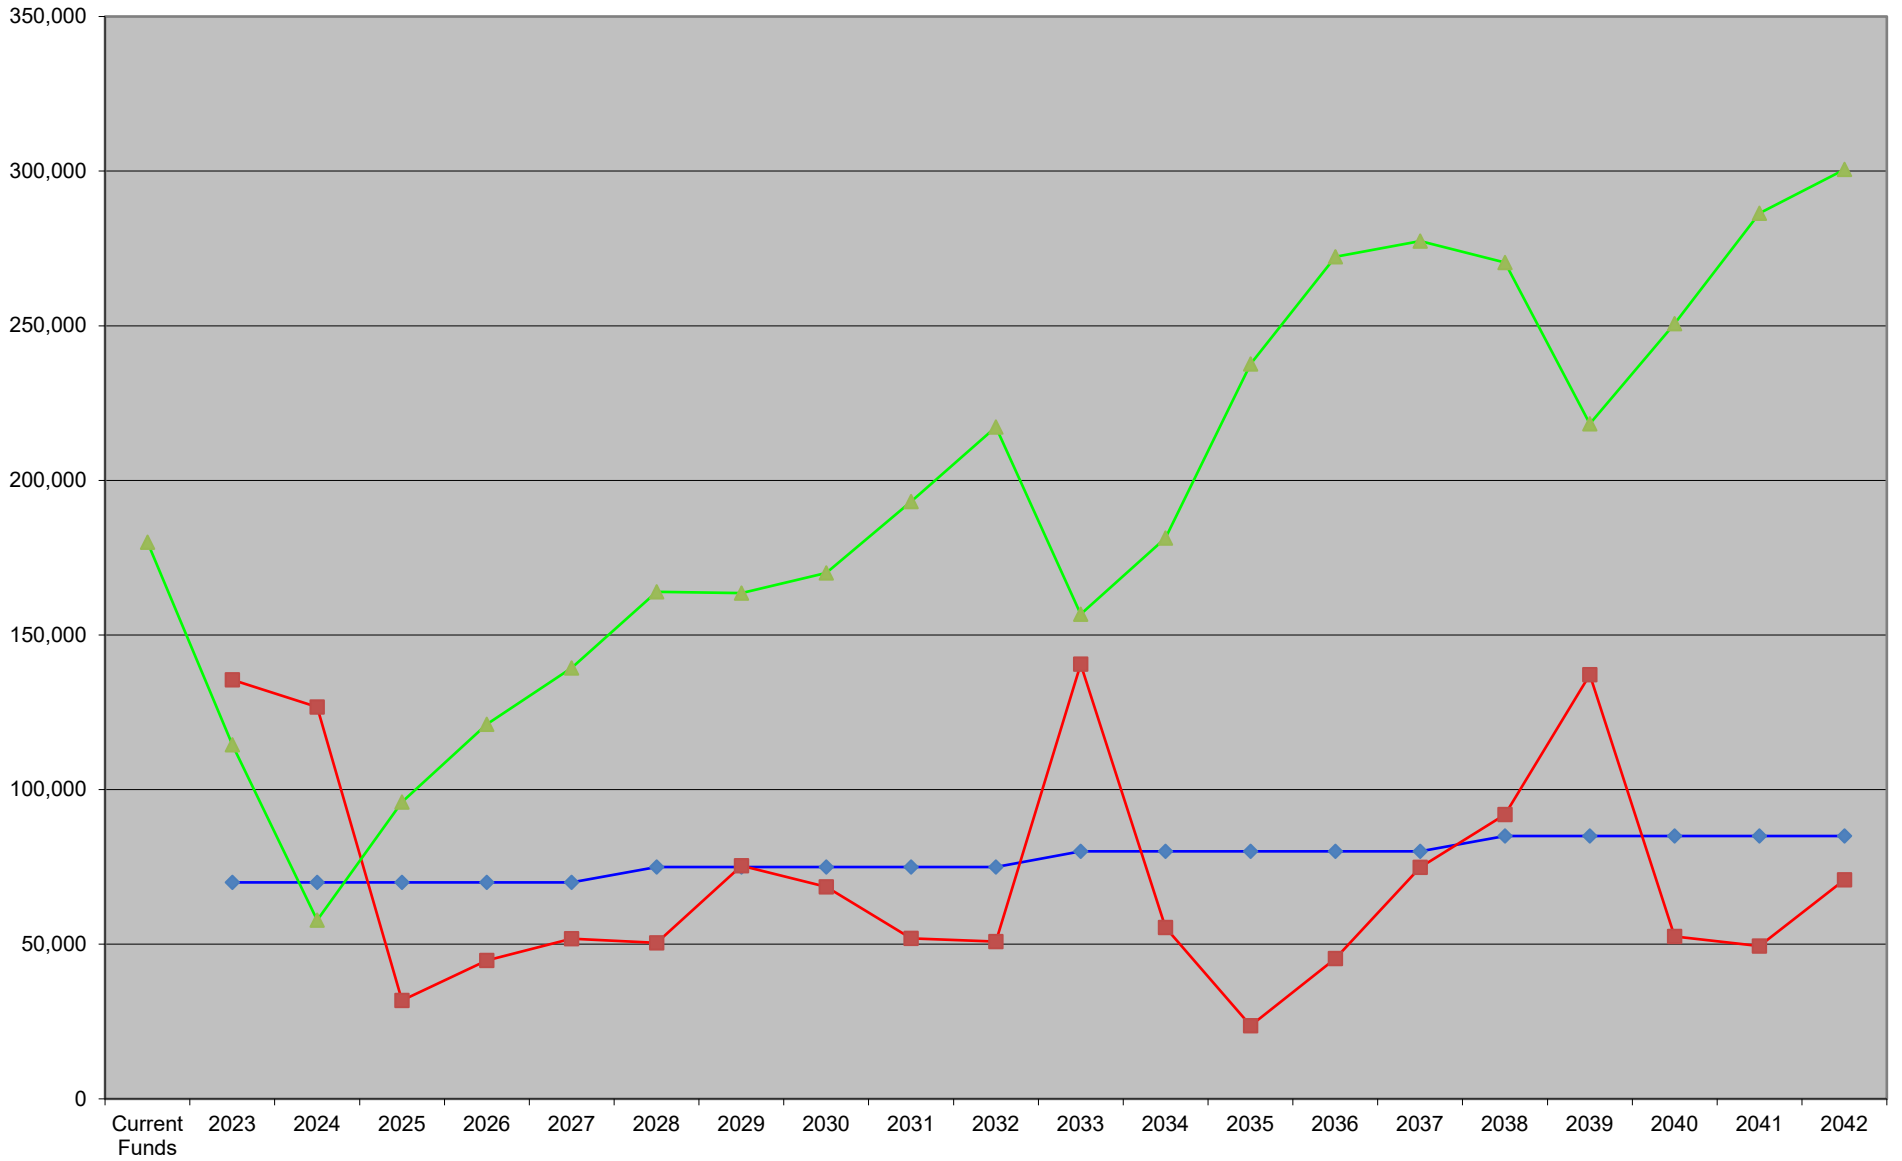
CEDAR MILL - PROJECTED CASH FLOW (CURRENT FUNDING)

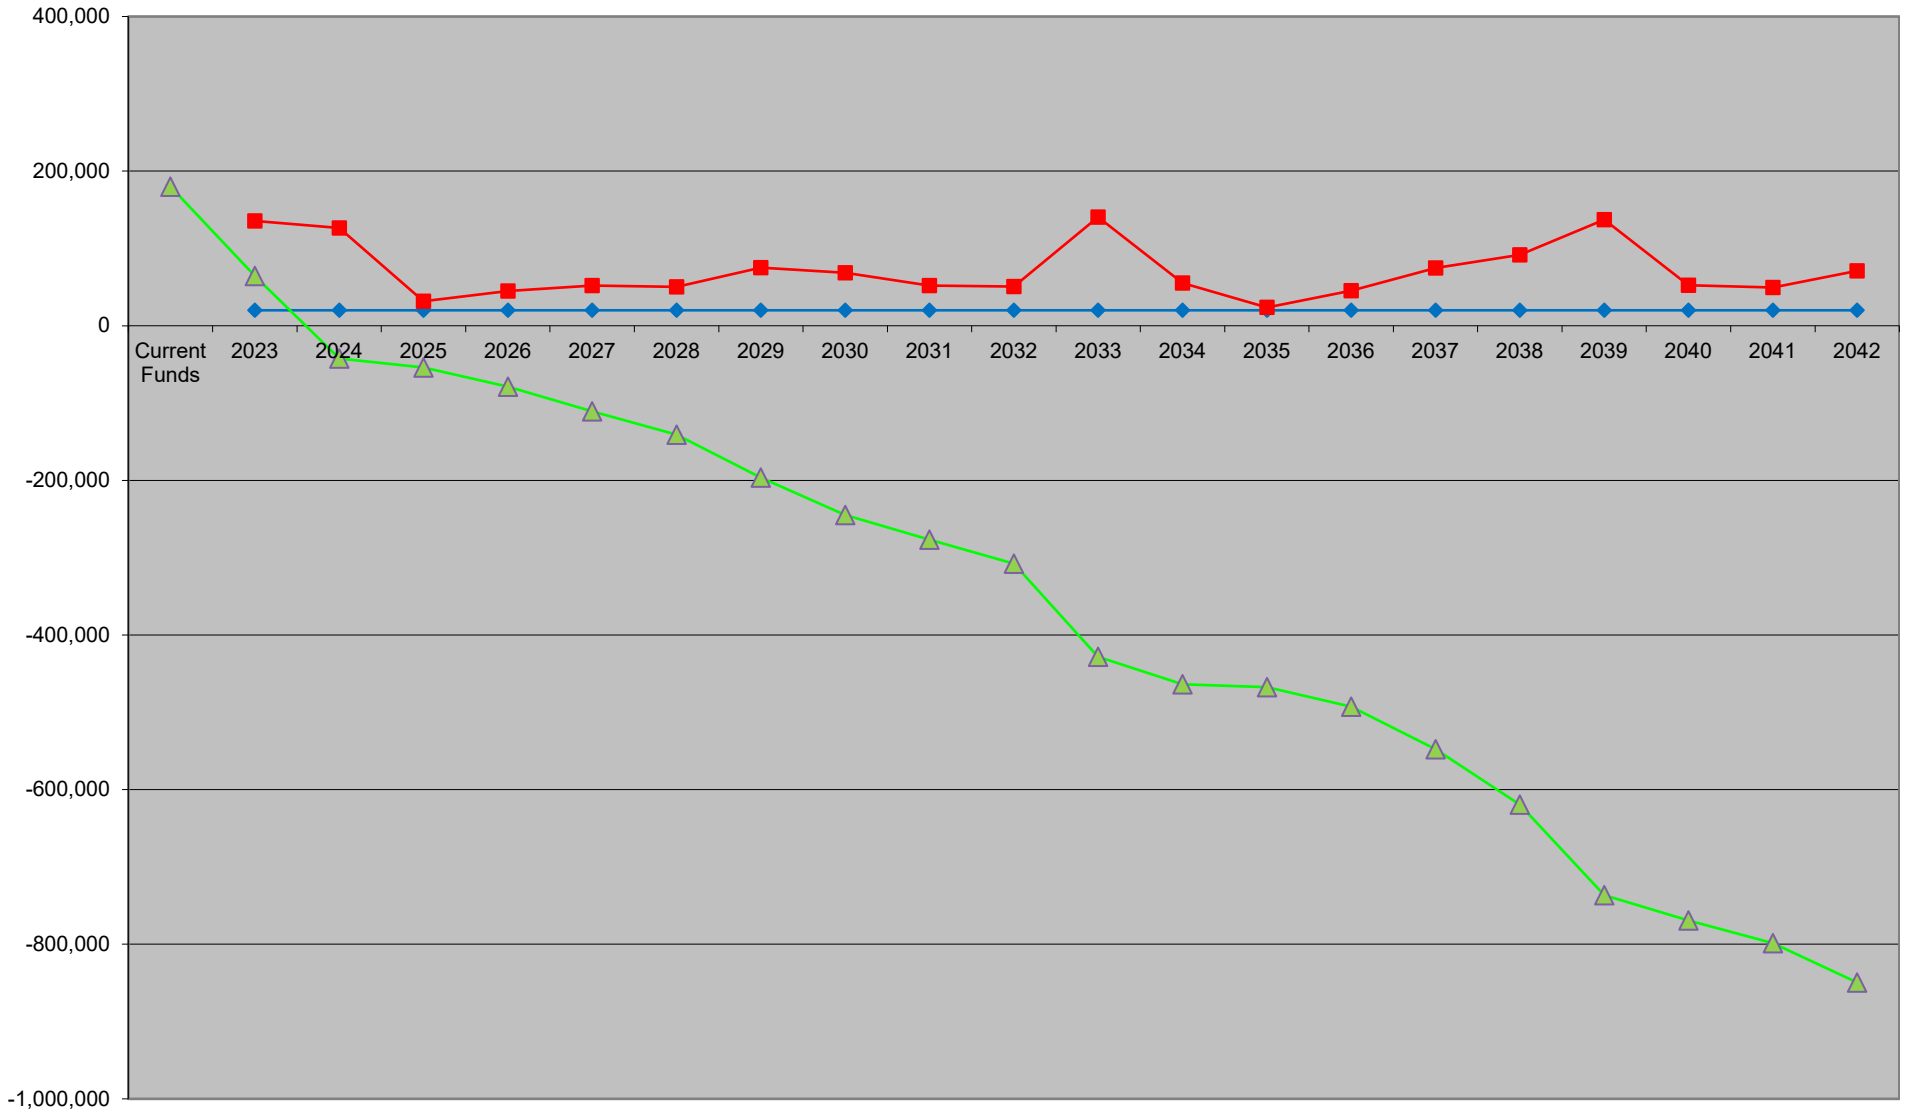
C. RECOMMENDATIONS AND CONCLUSIONS

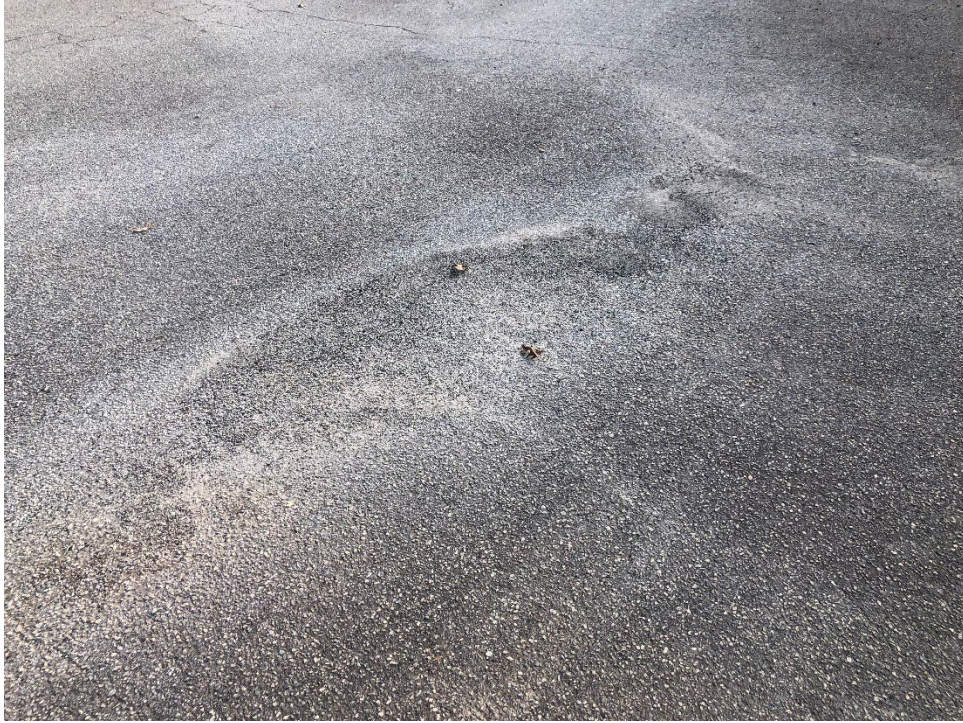
1. View of loose aggregates at the private parking lot.

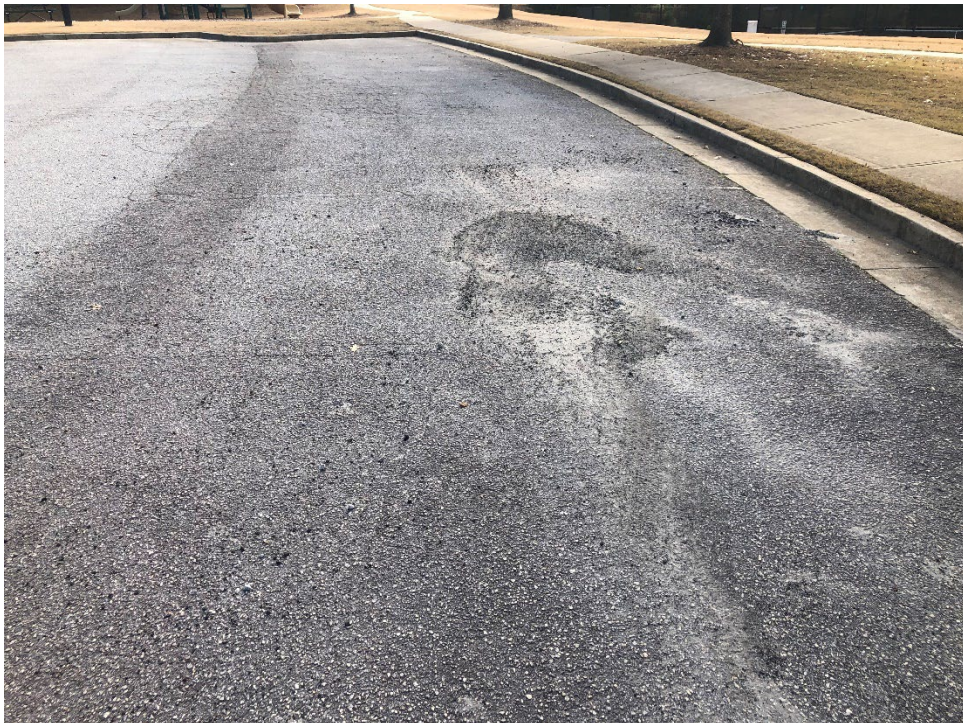
2. View of settlement and loose aggregates at the private parking lot.

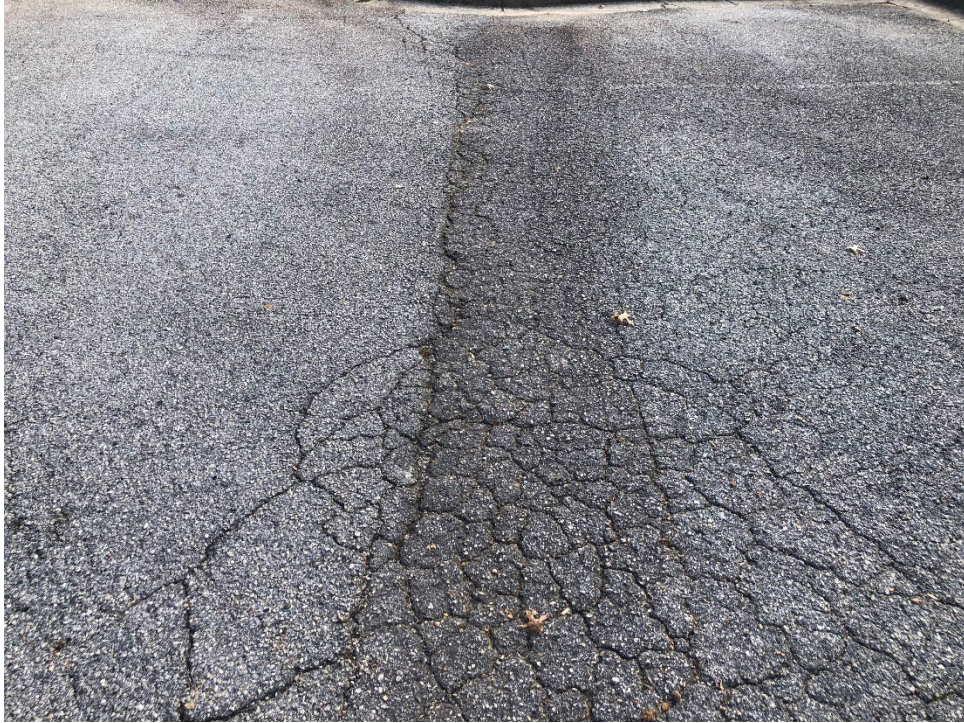
3. View of a typical "alligator" cracked at the private parking lot.

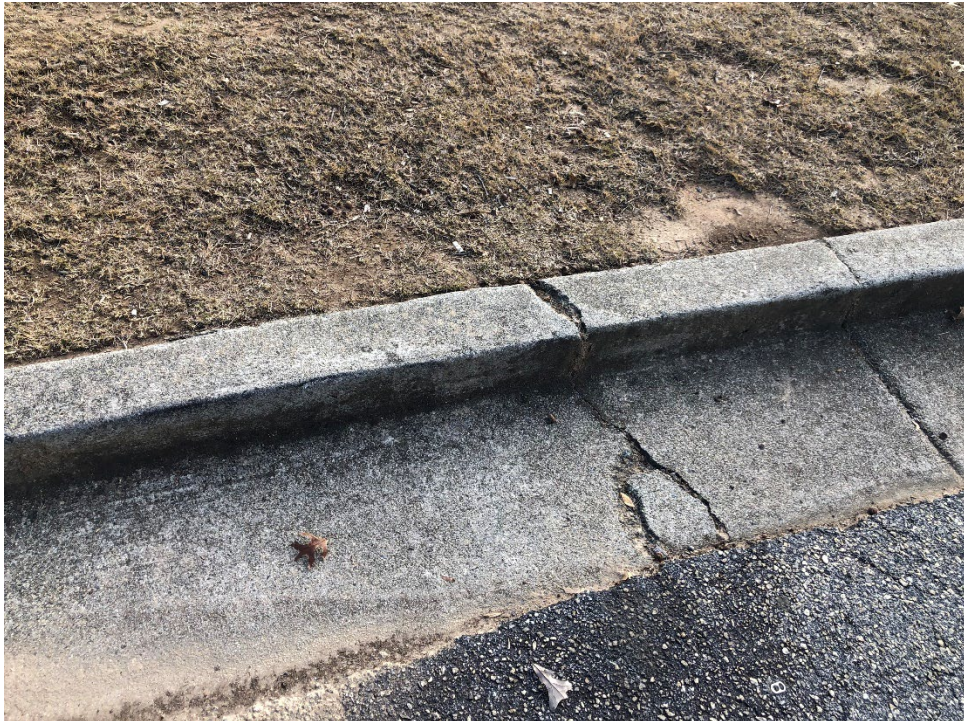
4. View of a typical crack with cracks and spalling concrete observed.

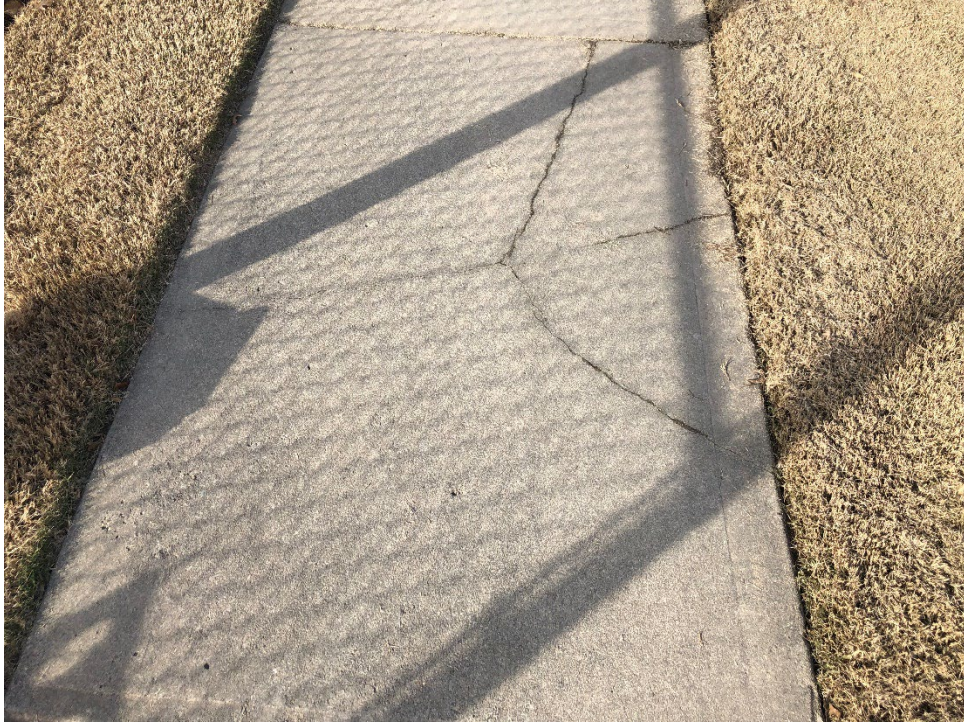
5. View of typical crack at the sidewalks.

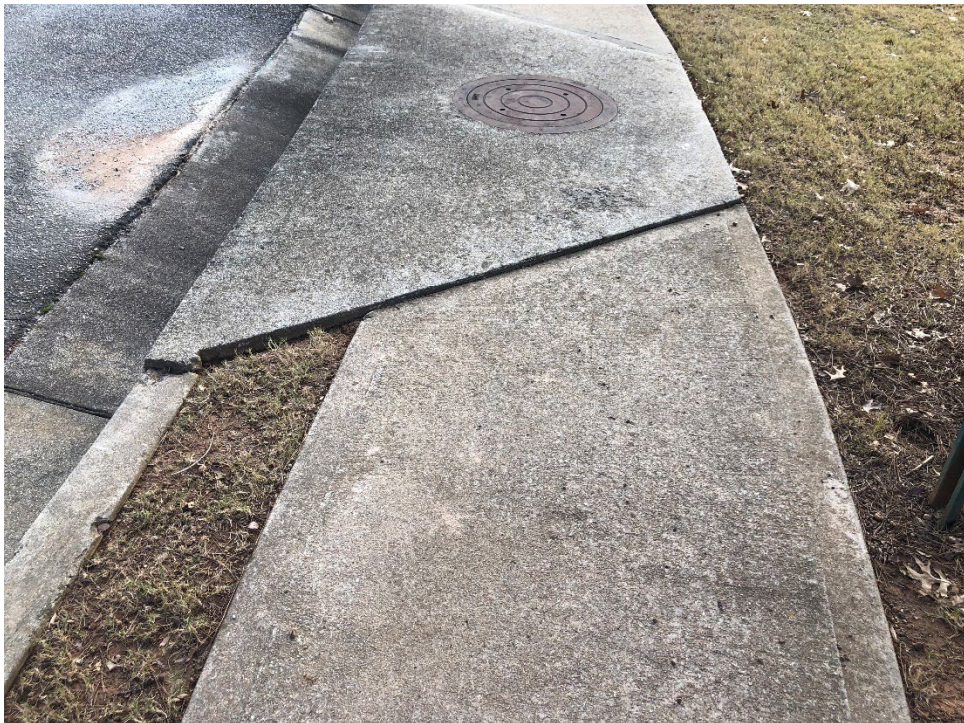
6. View of a settled sidewalk.

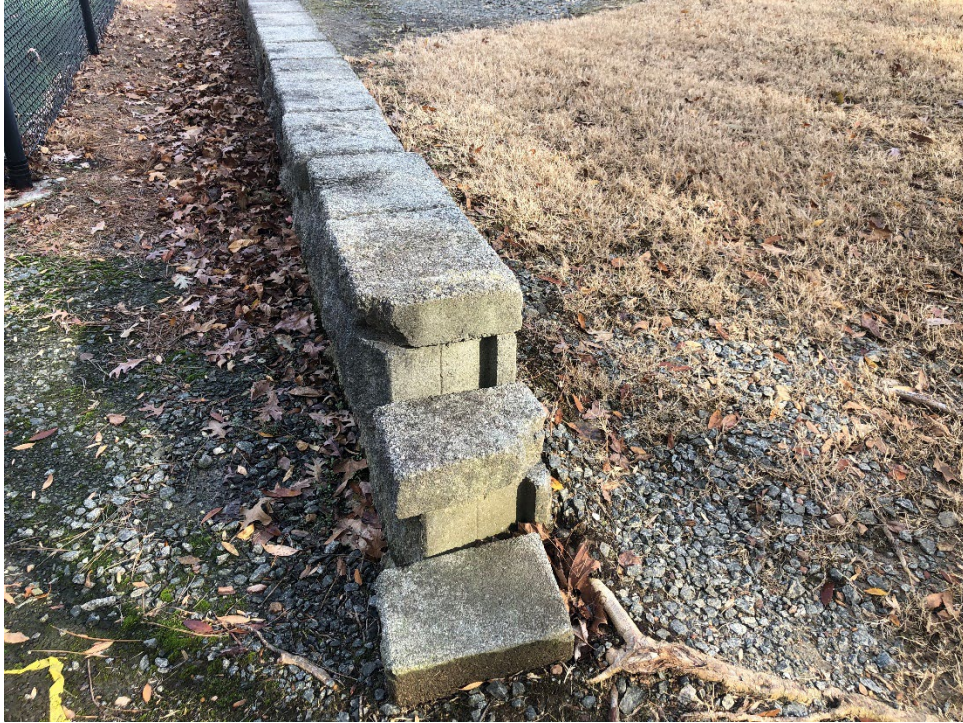
9. View of loose and displaced modular blocks at the retaining wall.

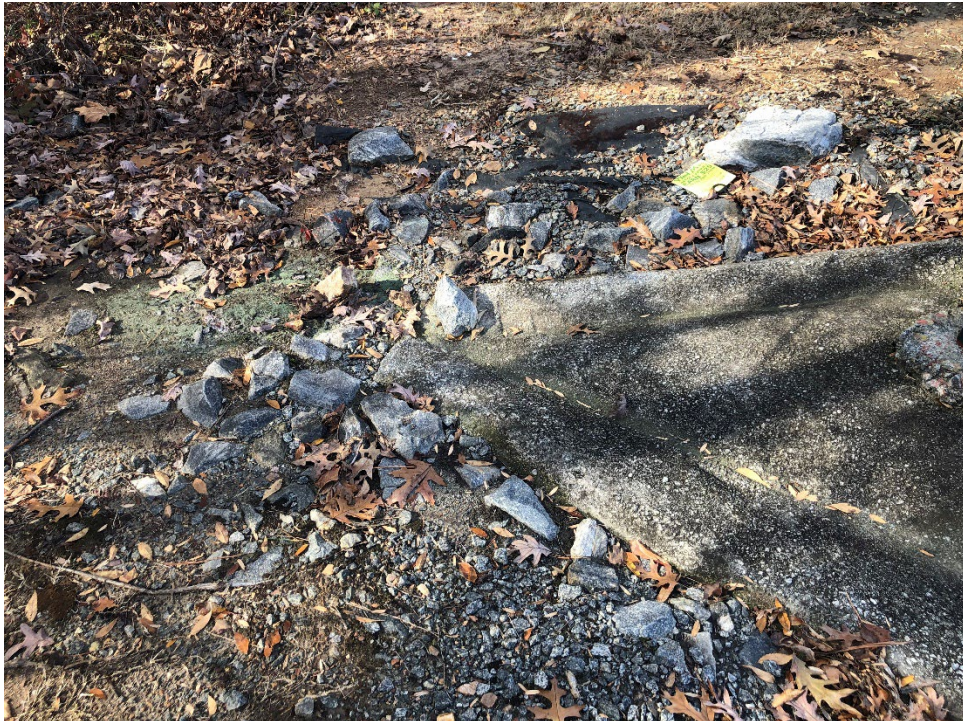
10. View of exposed filter fabric, displaced river rock and exposed soil.

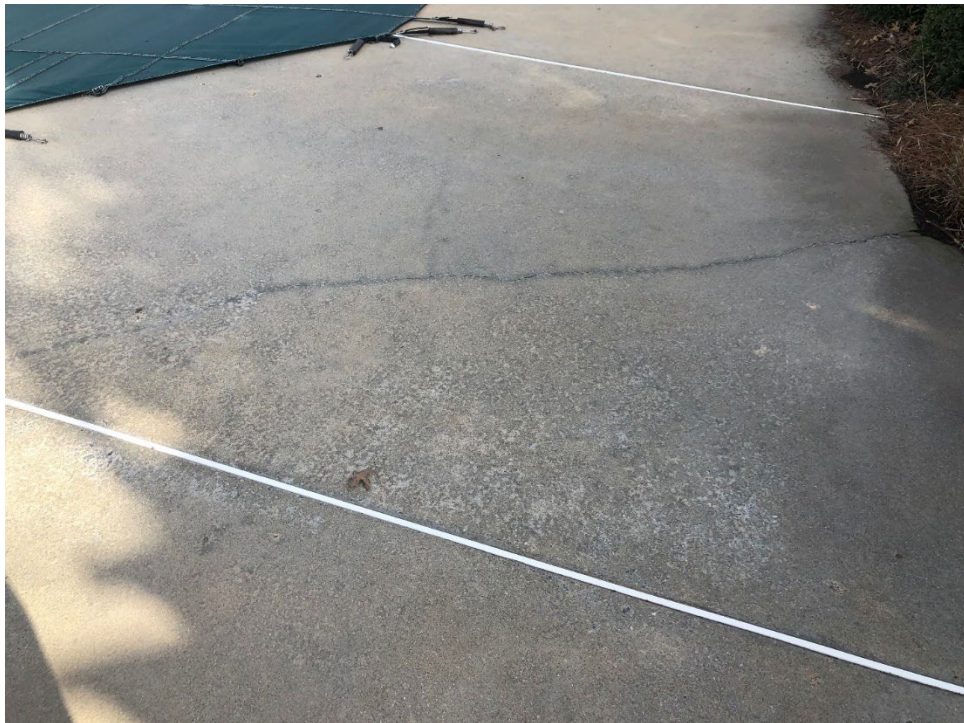
22. View of a crack at the swimming pool deck.

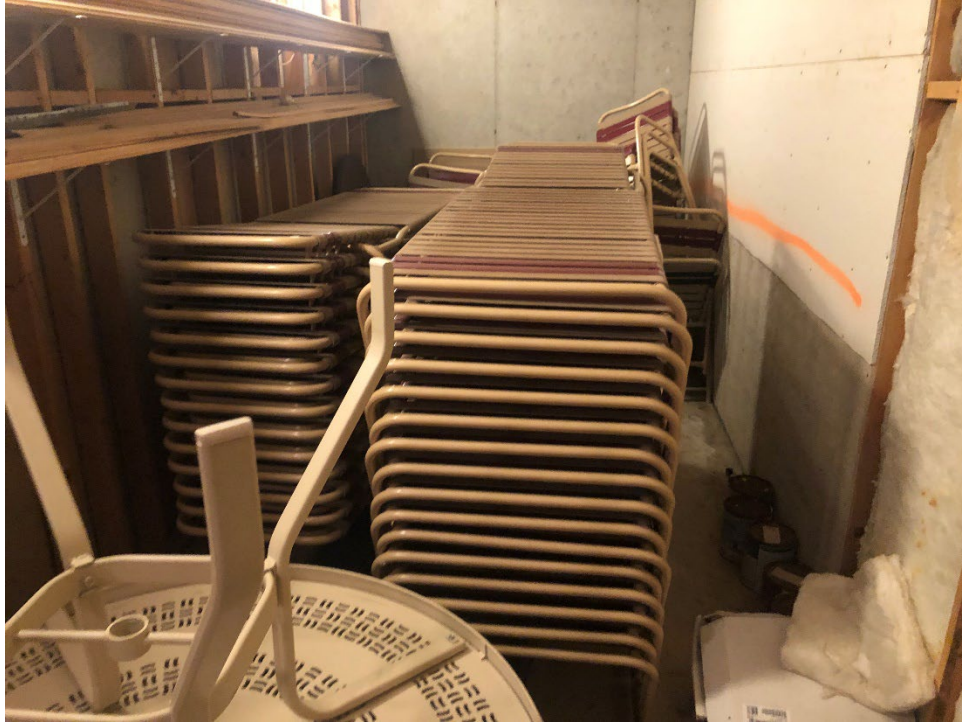
23. View of the swimming pool furniture.

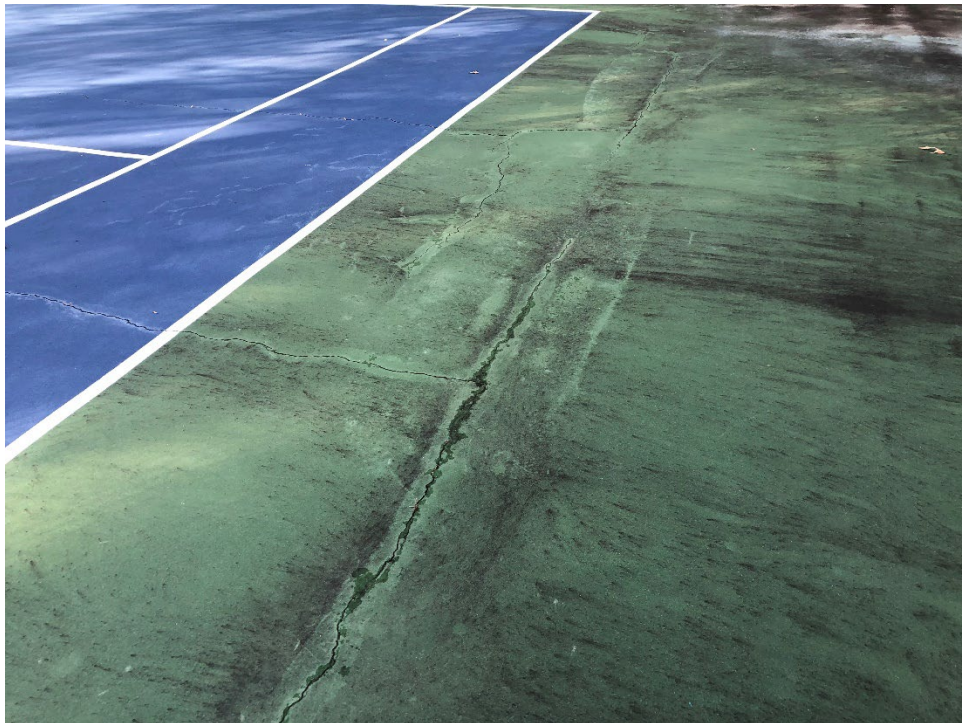
24. View of a typical crack at the tennis court.

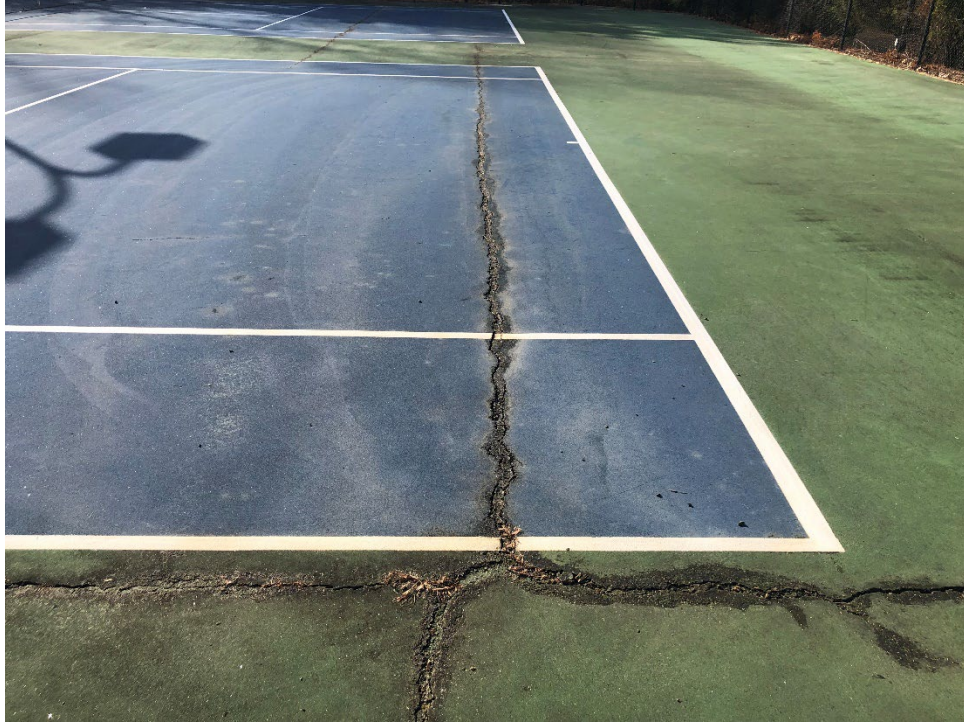
25. View of typical cracks at the tennis court.

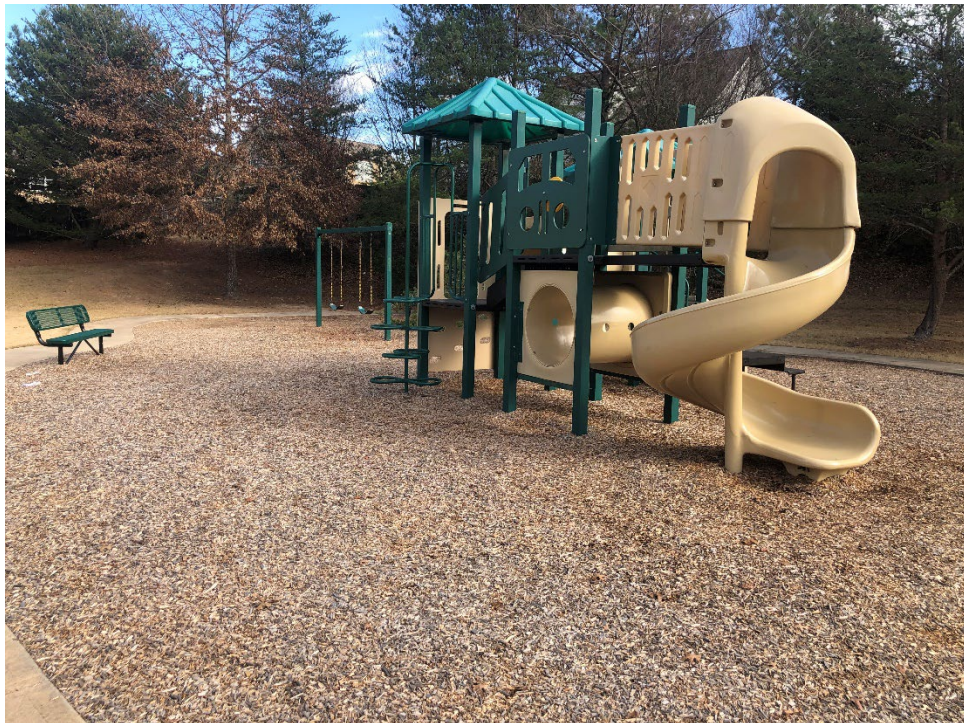
26. View of the playground.

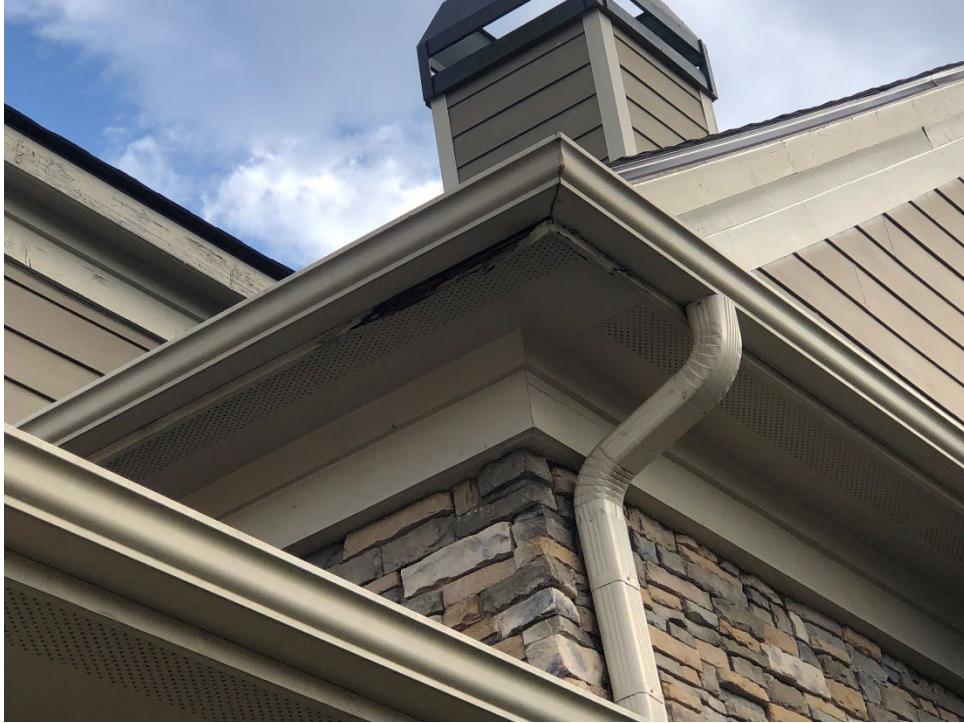
27. View of a typical damage soffit at the clubhouse.

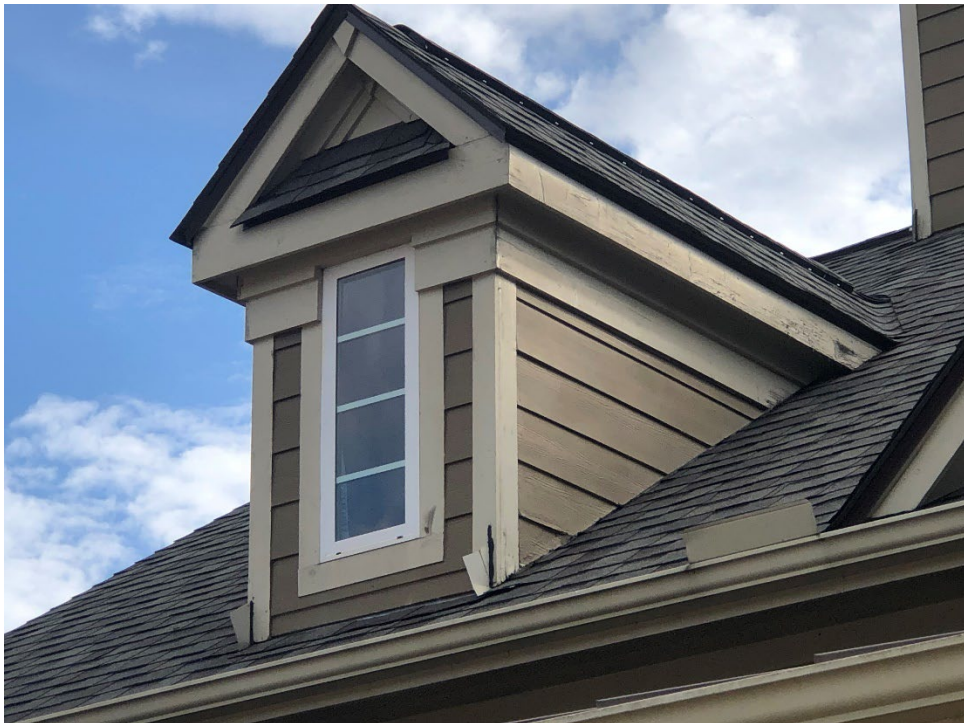
28. View of a typical damaged trim and fascia at the clubhouse.

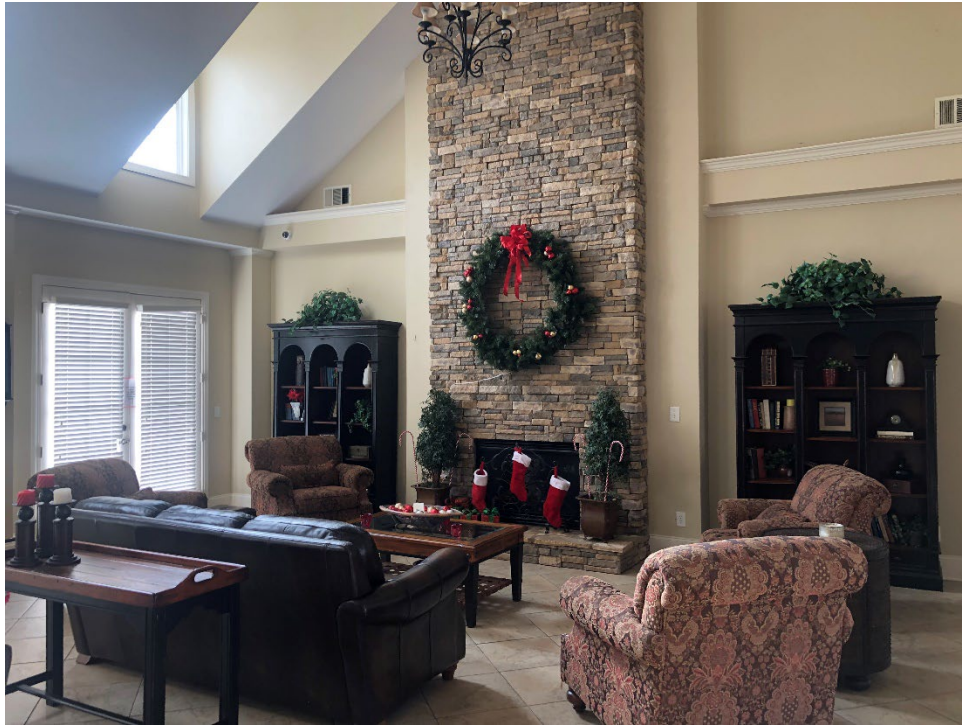
29. View of the main room.

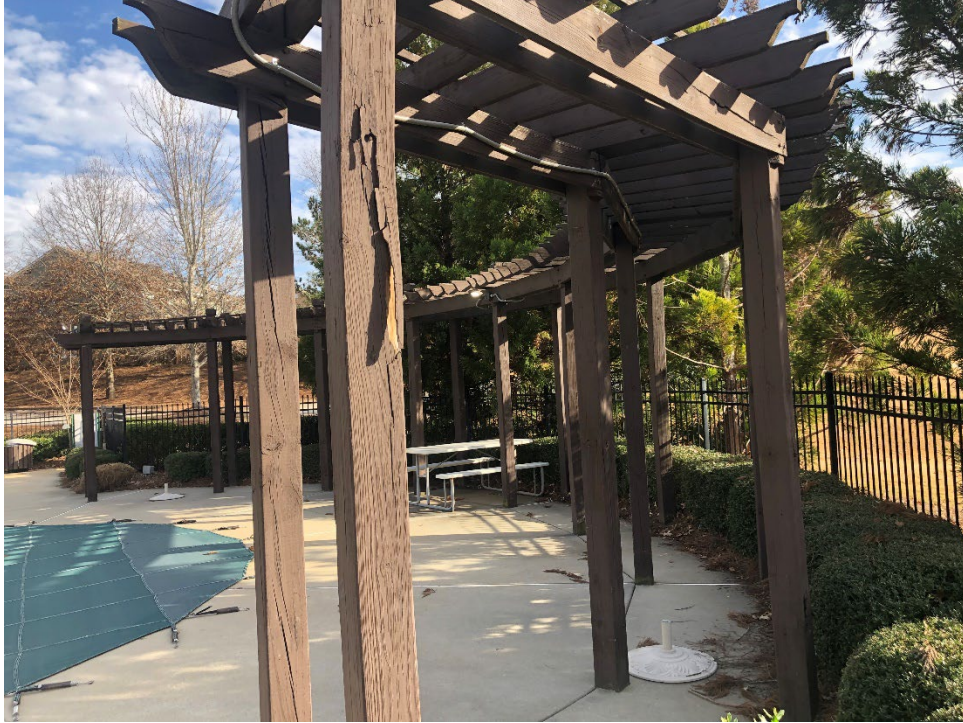
35. View of a damaged column and fading paint at the arbor.

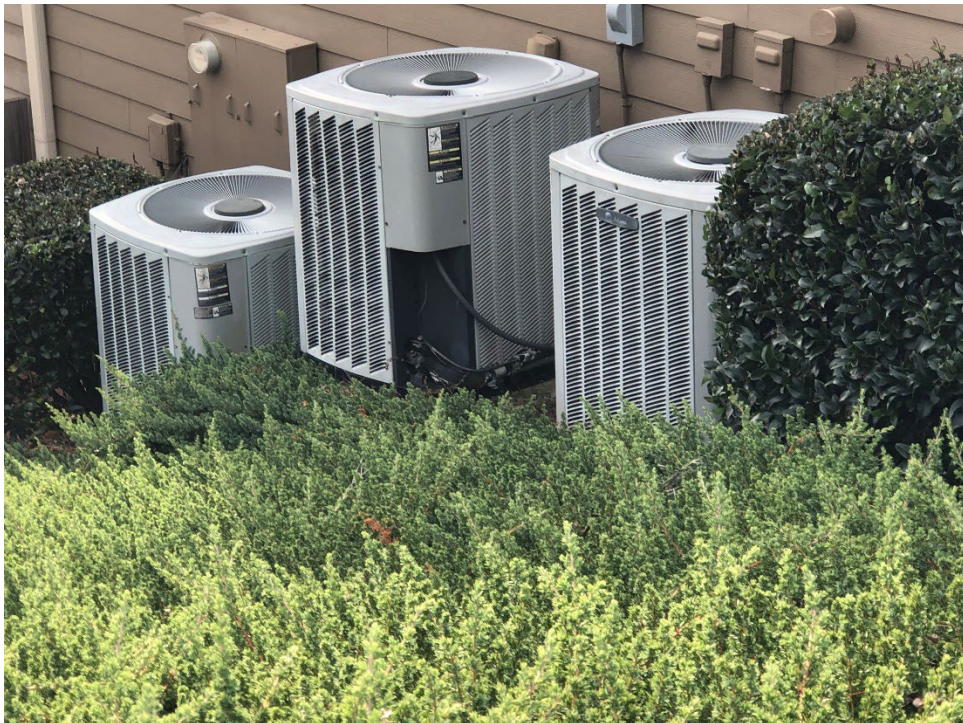
36. View of the typical HVAC units.
