**ESTIMATED RESERVE REQUIREMENTS  
FOR  
BROOKSTONE II HOMEOWNER ASSOCIATION**

Prepared by Huie Services, Inc.  
June 28, 2018  
© All rights reserved

### BROOKSTONE II HOMEOWNER ASSOCIATION CAPITAL RESERVE FUNDING

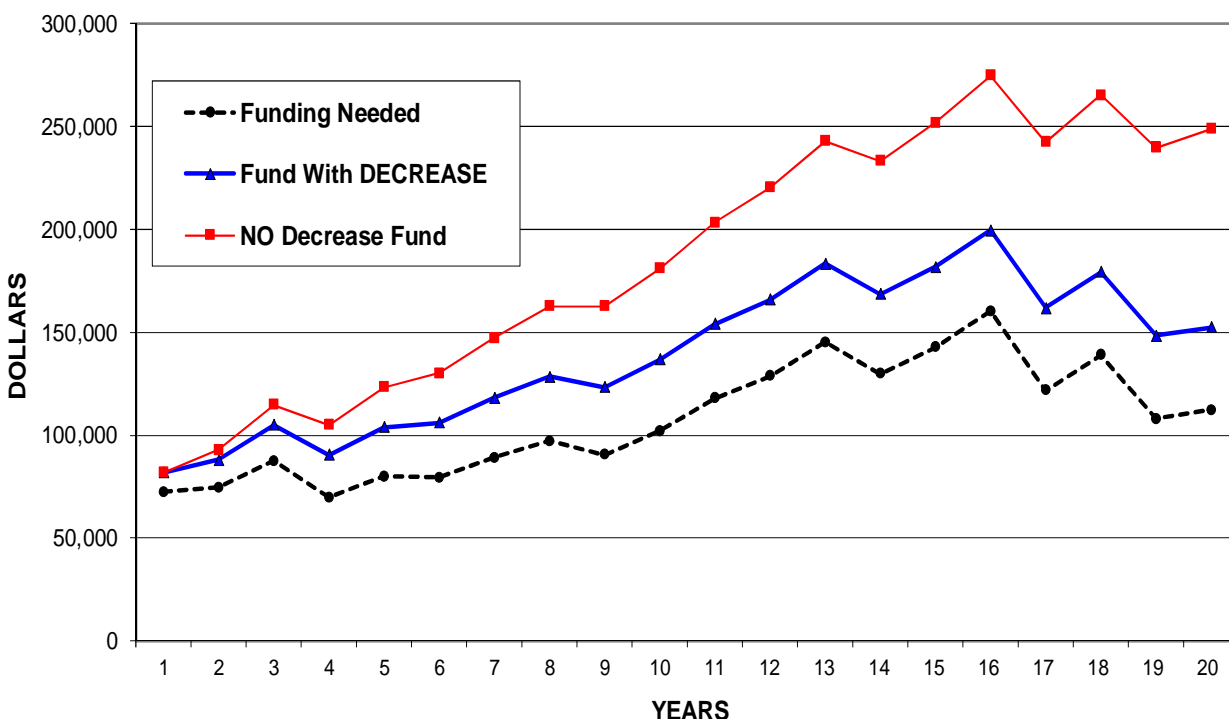
In regard to the Reserve Budget for the HOA, the three “big ticket” items- the amenity parking lot, the clubhouse interior and the playground have been rehabbed in the recent past, have long

lives and are in good condition. In the graph above this is demonstrated by the low and very slowly rising black dashed line.

1. Decrease the contribution to the Capital Reserve Fund from the HOA by \$12 per home per year in 2019.
2. Decrease the contribution to the Capital Reserve Fund from the Swim & Tennis Club by \$12 per member per year in 2019.
3. Consider the best approach for the surplus in the HOA Reserve Fund as discussed in the Contingency category on page 16.
4. Re-evaluate the amount contributed to the Reserve every few years to see if the assumptions are still correct. This report is not a warranty of the condition of the items included.
5. Present this report or a summary of it to the membership.

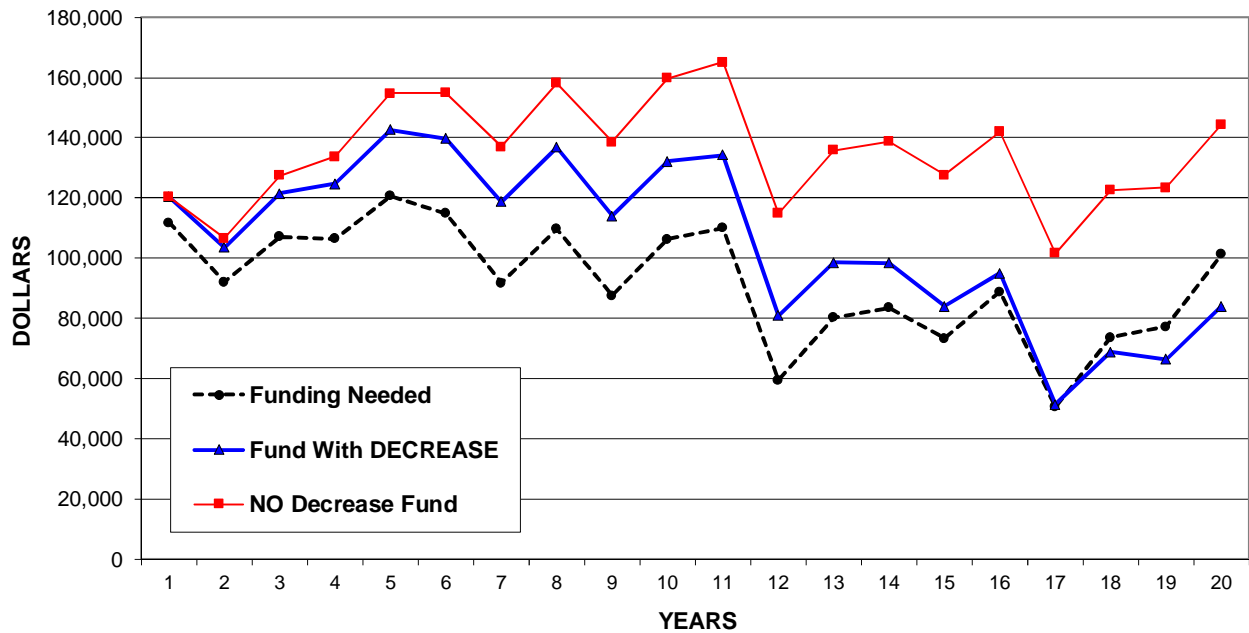
### BROOKSTONE II SWIM AND TENNIS CAPITAL RESERVE FUNDING

The S&T Reserve Fund will have more recurring significant expenses over the next twenty years as shown by the up-and-down movement of the graph.

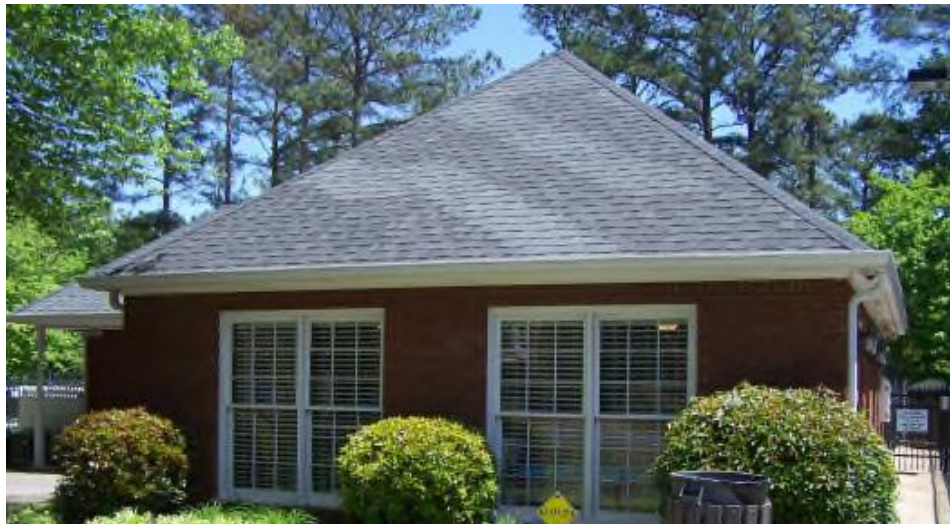
**Roofing and Guttering for Clubhouse** - 28-year normal life. The three-tab fiberglass-reinforced asphalt shingles on the roof at the time of the previous report have been replaced with architectural shingles. These shingles are better quality and have a longer life. In addition, they match the shingles on most of the homes in Brookstone II. The shingles are aging normally. There is a slight color variation that is due to a difference in shingles from one bundle to another.

When replacement is necessary it is recommended that you again use the "tear off" method that means that the old shingles are completely removed before the new shingles are applied. While it is not essential that the old shingles be removed before applying a second roof, it does give a longer life to the new roof, makes a more attractive roof and also allows defects in the decking and flashing to be clearly seen. It is also recommended that you re-roof with the 30-year architectural shingles. Some manufacturers have increased the warranty on these shingles to 35 years but the 28-year life shown is a reasonable estimate of the useful life of the shingles. When re-roofing is done, roof valleys should receive valley flashing to prevent leaks.

Also included is the cost to replace from 5 to 10 sheets of roof decking when the reroofing is done. Decking must be replaced principally because of either deterioration due to leaking or poor original quality.

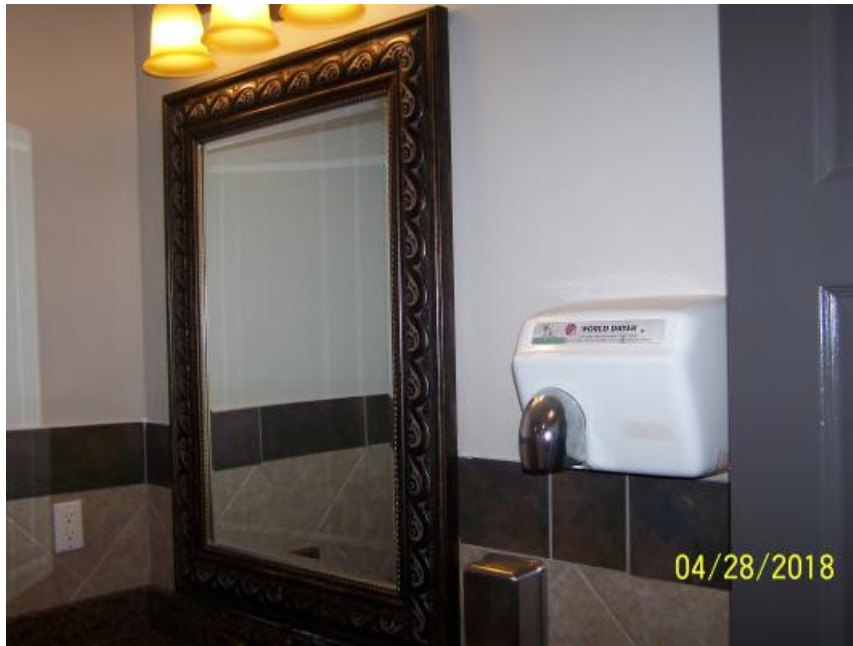
A major rehab of the bathroom areas was undertaken prior to the 2012 report during which the sinks, the tile floors, adding tile wainscot to the walls, light fixtures and toilet stalls were replaced. All of these items are in very good condition (see next photo) and are expected to have lives that exceed the previous 10-year life of the category so the costs listed below for those items have been reduced and the life has been extended to fifteen years. Other portions of the clubhouse will need attention.

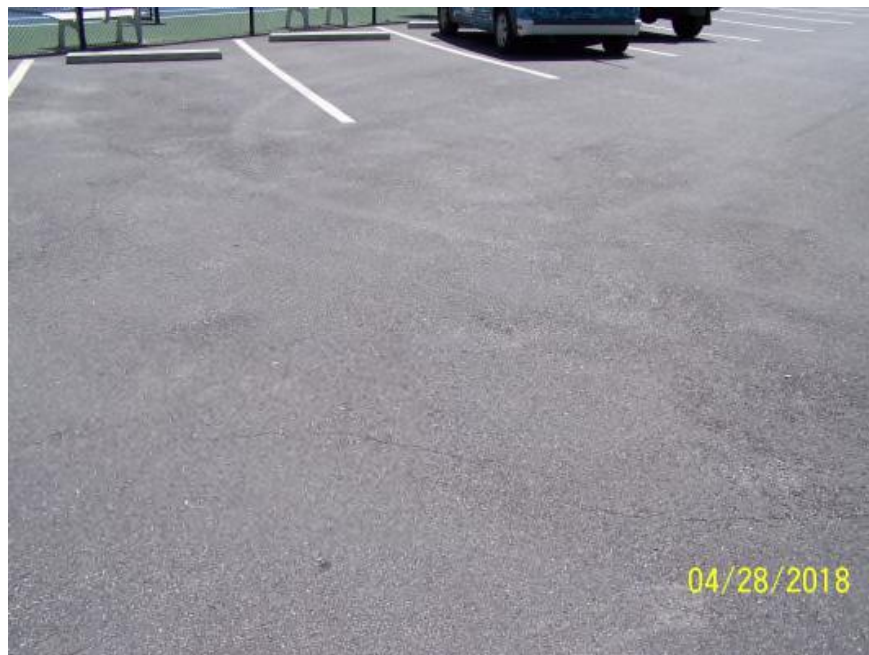
As discussed above the asphalt pavement has been replaced and in good condition (see next photo). The only required maintenance for the next few years will be re-stripping the parking spaces.

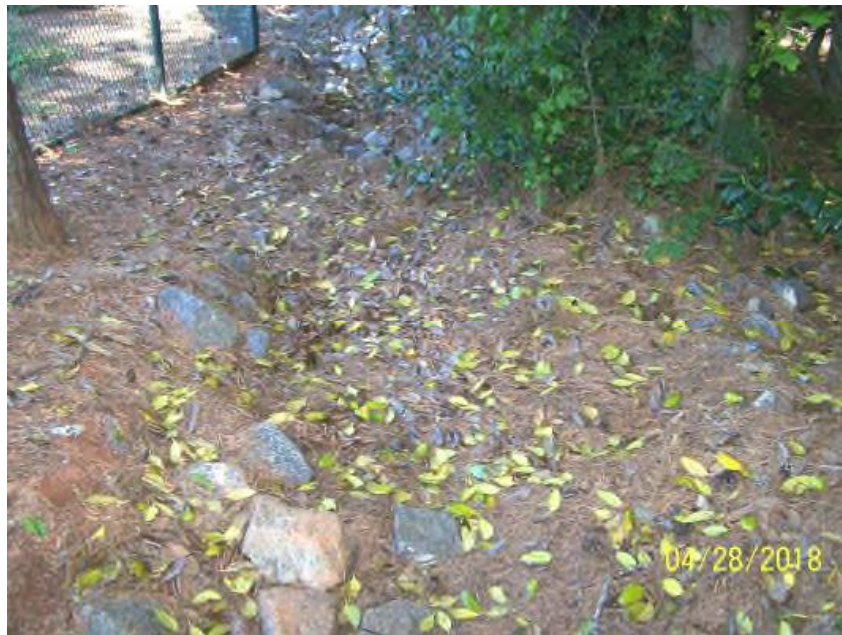
Drainage work on the surface of the ground to control and direct water run-off in the amenity and entrance areas was not a major issue at Brookstone II but a drainage issue did develop after the tennis courts were rebuilt. A drainage system was installed to direct the runoff appropriately but the rock-lined areas require periodic maintenance to align the stones in the drainage ditch. It was also noted that leaves and pine straw are starting to fill the channel and could push the water into undesirable areas.

While no indication was seen suggesting large problems in the short term and since small problems are generally considered to be normal general maintenance, this is a fund to provide for large problems (more than \$2,000) to any of these systems. There could be more than one repair totaling this amount every five years.

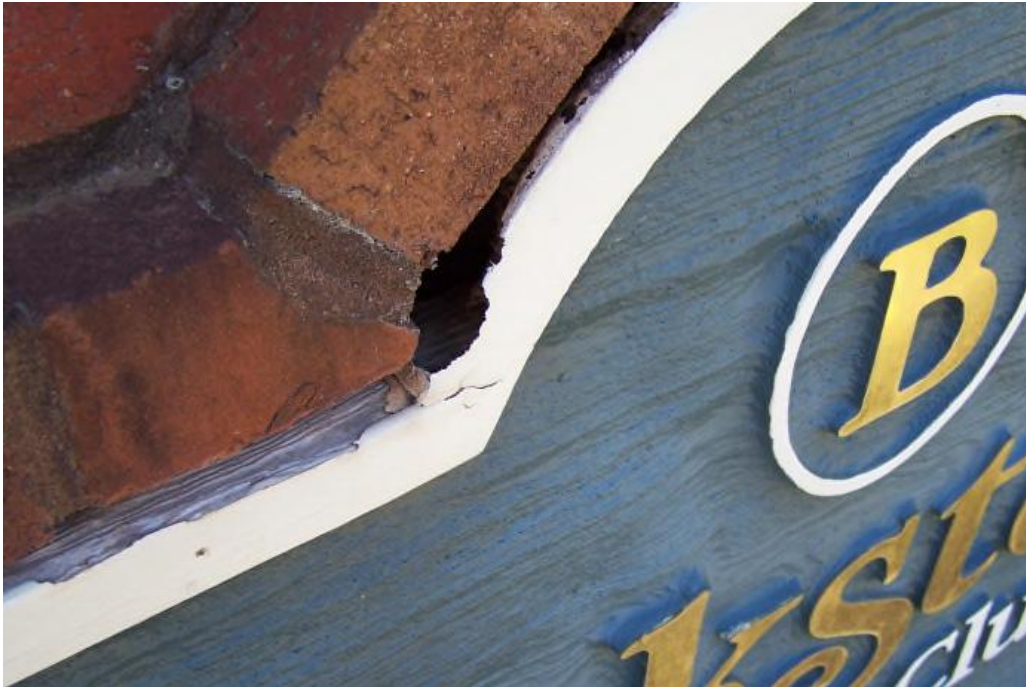
**Signage** - 20-year life. The property identification signage is found mounted to the brick monuments and columns at the main entrance and the various secondary entrances. The 5-foot by 2-foot signs at the main entrance on Mars Hill Road are sandblasted wood signs. The present signs at the main entrance are recessed into the face of the brick monuments. The signs are painted but the Brookstone letters are a metal veneer on the sign facing Fairwood Drive. The sign facing south has lost the metal veneer on three of the letters. Both signs have been refurbished, which is one of the advantages of a sandblasted wood sign, but they are reaching the end of their lives. The sign facing Fairwood has a rotted spot as seen in the next photo.

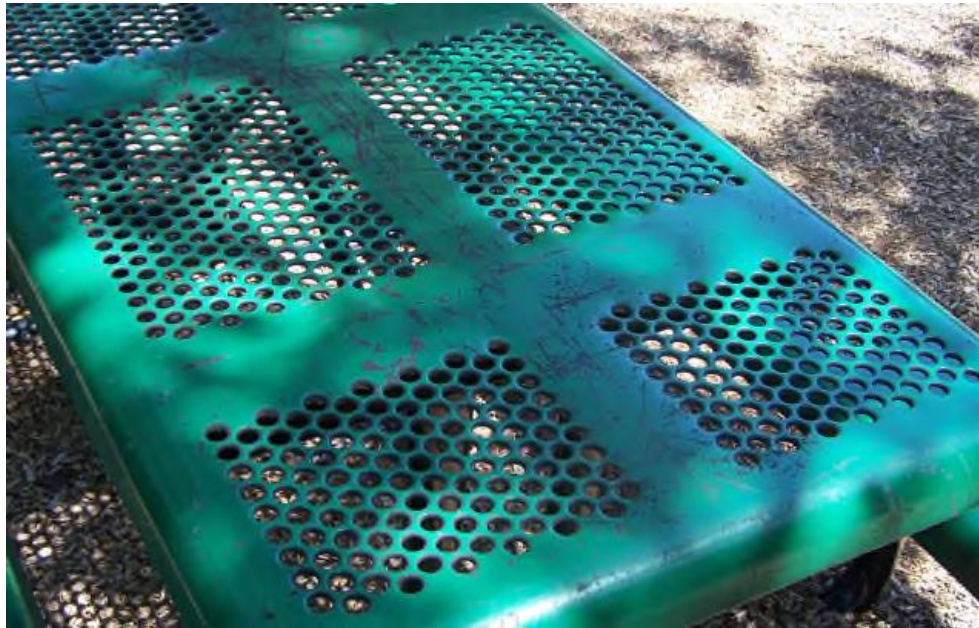
It was noted that the top of the picnic table is being abused (see next photo) but this has not caused any problem with its function.

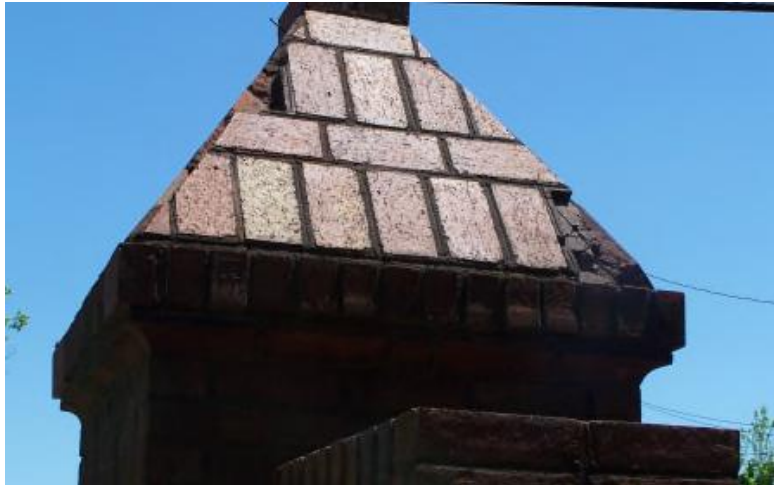
There is a large amount of brickwork at the entrances and the cabana brick veneer. These structures are not significantly different now than they were at the time of the previous report but some minor problems have developed. At the monument some bricks have fallen out of the top portion (see next photo).

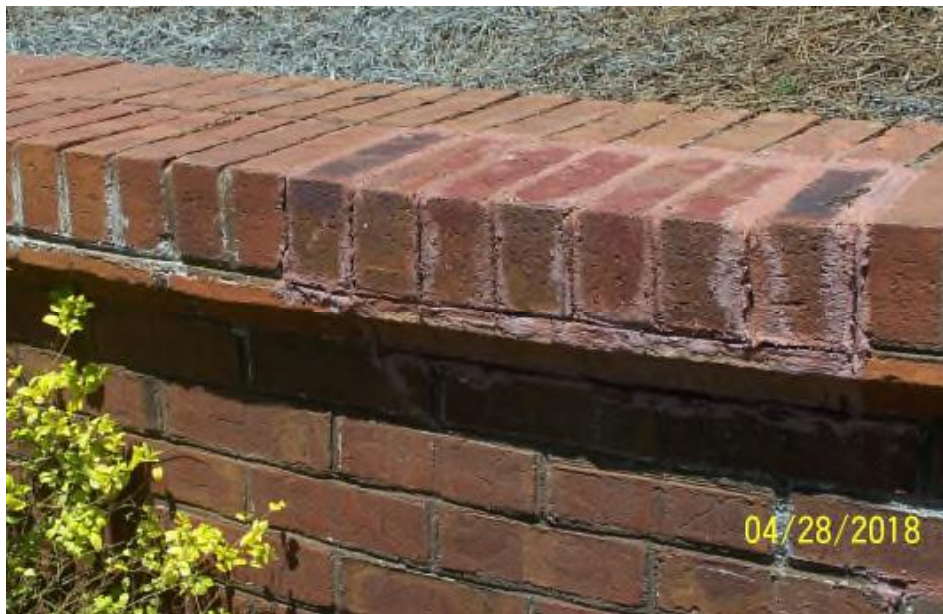
There are also some loose bricks on the front lip of the wall on the opposite side of the entrance (see next photo) as well as some white staining. The staining appears to be a common problem called efflorescence where “salts” in the masonry or soil are dissolved by rain, carried through the brick and left on the surface as the water evaporates. This problem, while somewhat unsightly, does not harm the structures. This can sometimes be helped by dusting off the white powder and applying a water repellent coating but repairing the mortar joints on the tops of the pillars and monument will be necessary to keep the water out.

The repairs to the wall in the previous photo are not comparable to the original construction. A qualified mason is desirable because inexperienced workers will often perform work that is aesthetically undesirable.

This category funds a periodic repair project by a qualified mason to all of the masonry structures rather than the repair of one small item at a time.

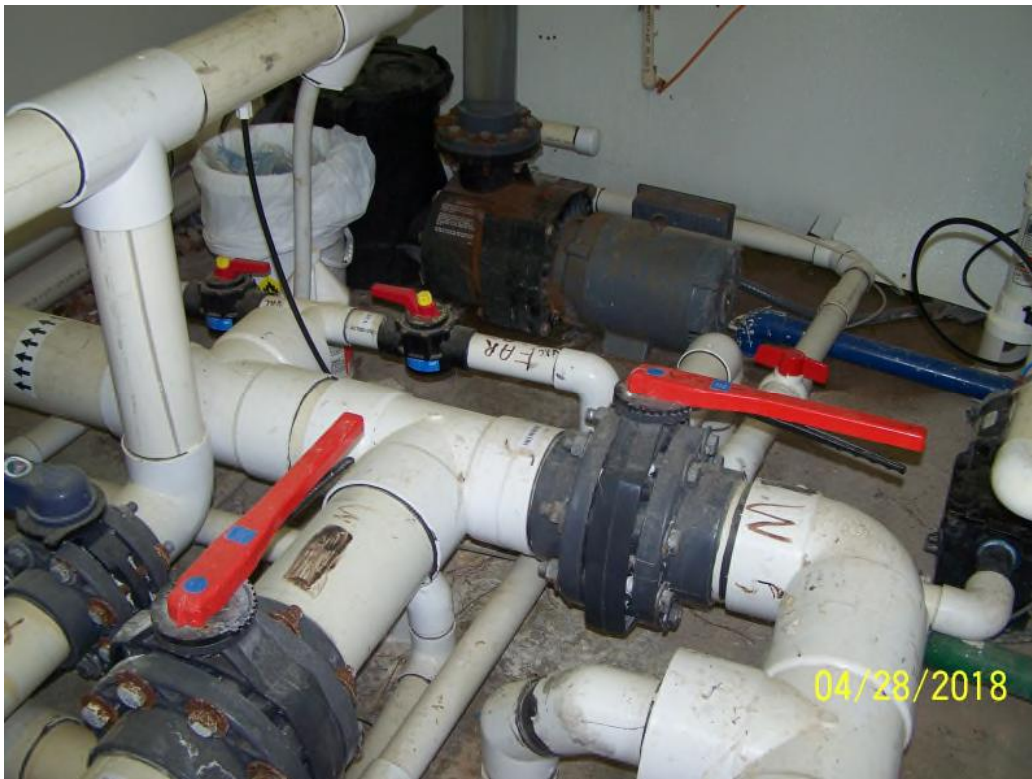
**Pool Equipment** - 8-year normal life. Brookstone II has two complete recirculating systems- one for the main pool and one for the children's pool. The main pool system includes a 7.5-HP motor and heavy duty pump and four large sand filters. The chlorination is provided by two chemical feeder pumps that are controlled by a sensor system. The equipment for the children's pool is a 1-HP motor and a light duty pump, one small sand filter and one small erosion chlorinator. The valves and piping are good quality. Also and skimmers. In speaking with Chad Freeman of Nautix Pools, the sand filters that were replaced this year at a cost of \$10,000. The remainder of the equipment is generally in fair condition.

It is understood that consideration is being given to reconfiguring the equipment in the pump room to make it operate more efficiently and be easier to maintain. Nautix estimates that this work would cost \$18,000 to \$20,000.

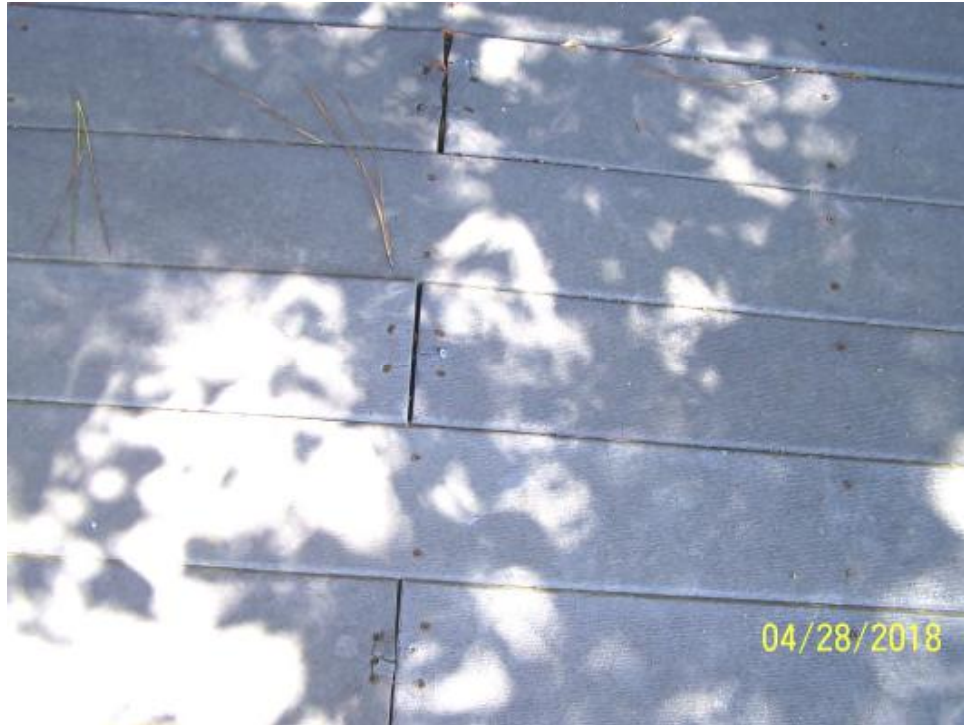
When the wood fence was replaced, a composite wood deck was installed next to the pergola to supplement the concrete pool deck. The composite boards were not performing as well as expected at the time of the previous report, but they do not appear to have developed any additional problems although a few boards have been replaced. There are still some issues at the end joints (see the next photo).
